Radiograph Interpretation - Welds

Discontinuities

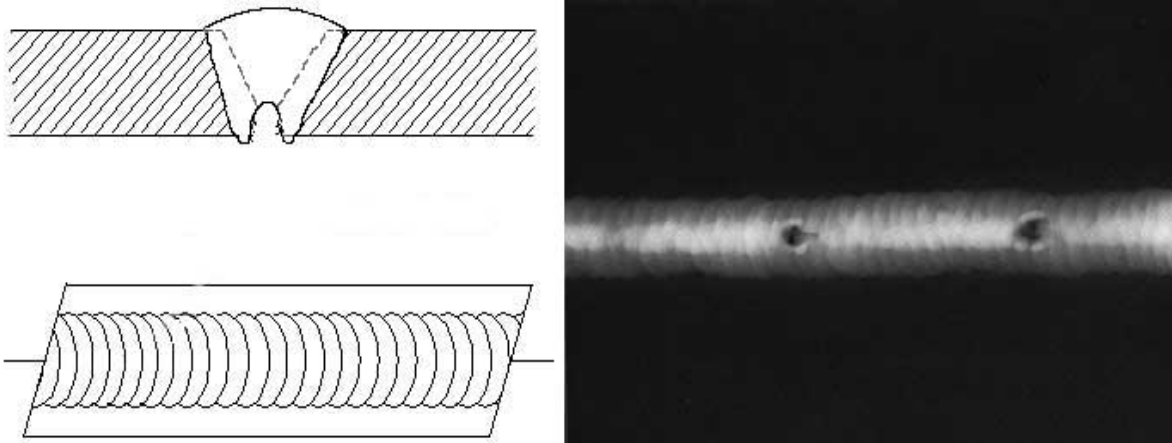
Burn-Through results when too much heat causes excessive weld metal to penetrate the weld zone. Often lumps of metal sag through the weld, creating a thick globular condition on the back of the weld. These globs of metal are referred to as icicles. On a radiograph, burn-through appears as dark spots, which are often surrounded by light globular areas (icicles).
